Environmental Performance of Treated Wood Cooperative

Ninth Annual Report

Oregon State University

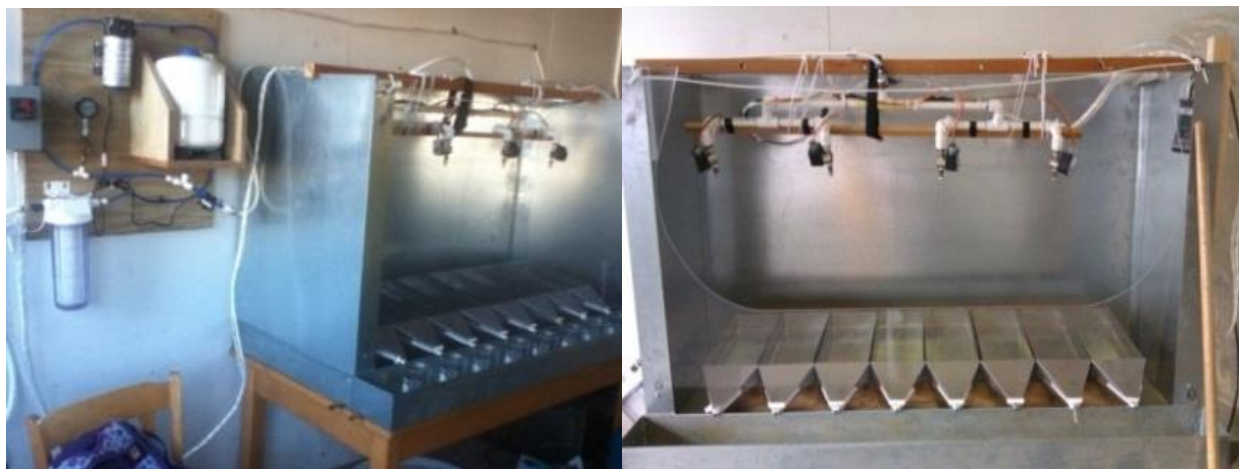
Figure 1. Overhead leaching apparatus used to evaluate the effects of BMPs on metal migration from preservative treated wood.

Samples were thawed overnight before testing. The potential for preservative migration was evaluated in a specially constructed overhead leaching apparatus that applied a controlled amount of simulated rainfall at a desired temperature (Figure 1). Previous studies (Simonsen et al, 2008) have shown that migration is independent of both temperature and rainfall rate so the device operated at room temperature (20~28 °C) and a rainfall rate ranging from 0.1 cm/h to 0.3 cm/h.

The apparatus (1.5 m wide x 0.6 m long x 0.9 m) was constructed with stainless steel and a plastic panel and had eight 152 mm wide x 457 mm long x 51 mm high sample holders. Holders were placed on a shelf with a 4.5° incline from the horizontal to allow water to flow down the wood. Simulated rainfall was produced by four spray nozzles connected to a deionized water supply. The rate of water spray was controlled by a small pump and an electronic controller. A pressure gauge near the spray nozzles also helped control flow.

BMP-treated samples were placed into each holder and subjected to simulated overhead rainfall for 2 hours. Previous tests had shown that metal levels in runoff drop off sharply to a steady state by this time. Runoff was collected in tared Erlenmeyer flasks that were weighed after rainfall exposure to determine the total volume of water applied per board for each time period. The weight of water was recorded and 4.85 mL of each water sample was placed into a vial. Water was collected at 15-minute intervals for the first hour then at 30-minute intervals for the last hour. Preservative retention in the samples was determined using either net solution uptake for SYP samples treated with waterborne preservatives or by x-ray fluorescence for both SYP and HF samples treated with oil-borne preservatives.

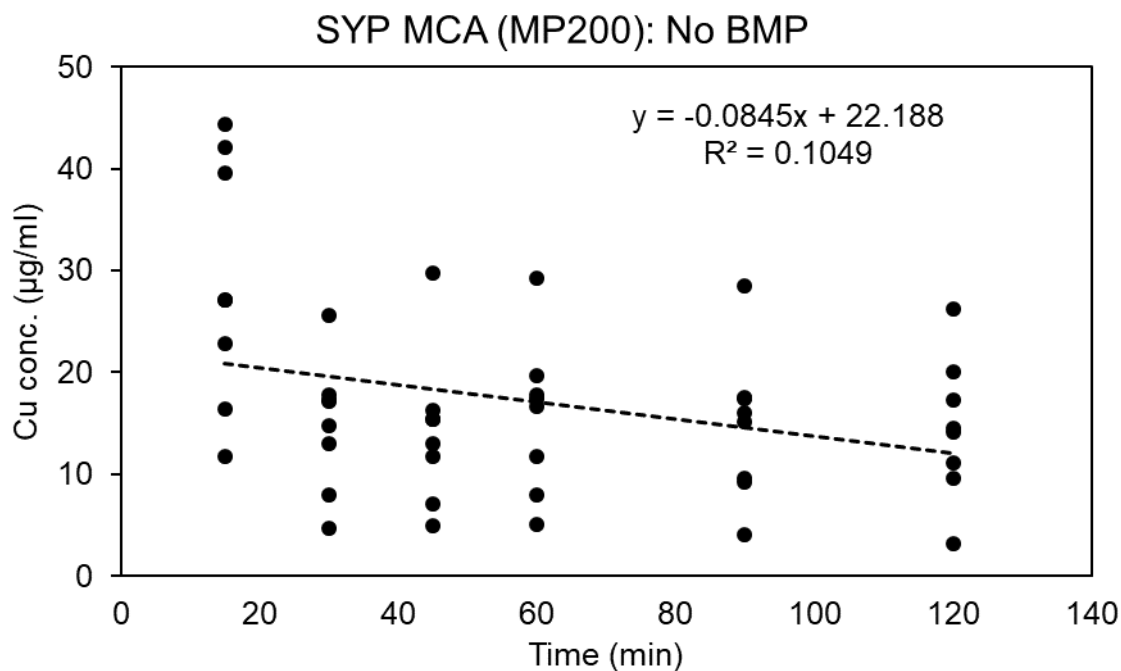
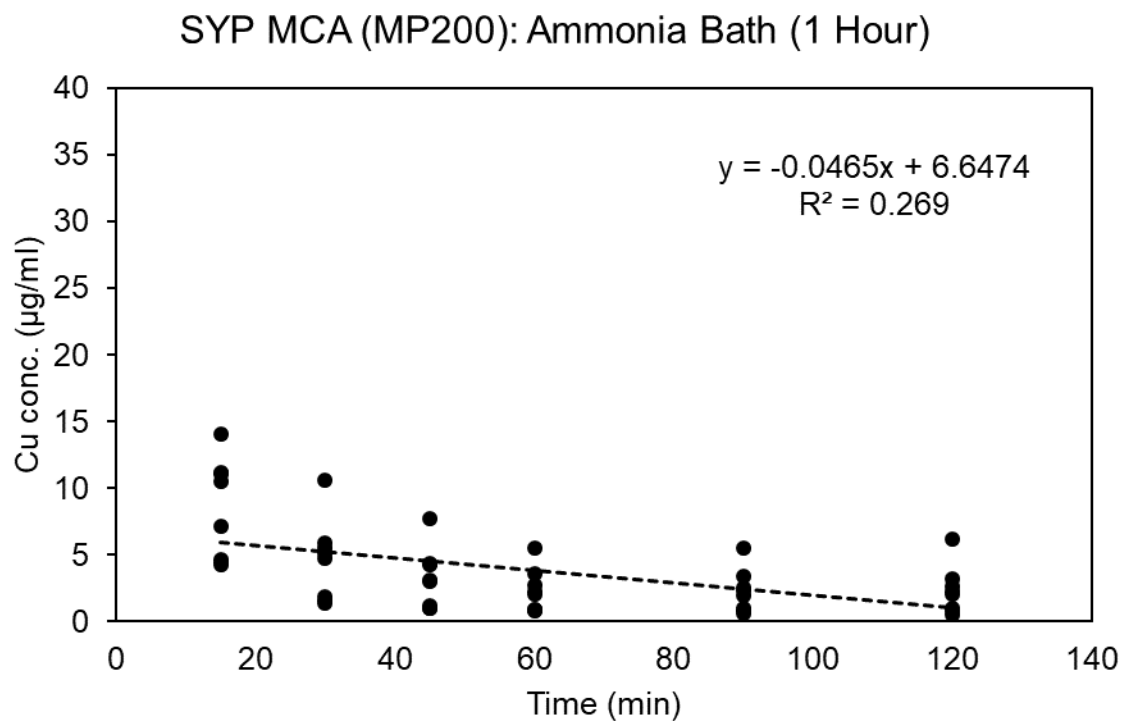
Figure 2. Effect of various BMP processes on copper losses from MP200 MCA-treated SYP lumber exposed to simulated rainfall. All data except air-dry BMP was previously published in the 2018 report.

For both wood species treated with no BMP, copper concentrations in runoff were generally higher in MP200-treated wood, especially in Hem-Fir wood. For SYP this was likely due to higher overall retentions in the MP200-treated wood, but the retentions for MP200 and Wolman MCA were similar in Hem-fir indicating another factor was driving the difference in runoff concentrations from Hem-fir wood. Average copper concentrations were highest in runoff from the first 15 minutes of simulated rainfall and decreased in the next 30 minutes to levels that ranged from 21-67% of the initial impulse (Table 2). Copper concentrations in runoff rapidly stabilized in MP200-SYP and maintained similar levels through to 120 minutes of simulated rainfall (Figure 2). Average copper concentrations in runoff from MP200-Hem-Fir continued to decline through the entire 120 minutes of rainfall, ending at 31.13 µg/mL, only 21% of the initial impulse concentration (Figure 4). Average copper concentrations in runoff from Wolman-SYP continued a steady decline less sharp than the drop in concentration between 15 and 30 minutes reaching 1.23 µg/mL, only 17% of the initial impulse after 120 minutes of rainfall (Figure 3). Wolman-Hem-Fir continued a steady decrease in average runoff copper concentrations after 30 minutes reaching 14.23 µg/mL, 51% of the initial impulse, after 120 of rainfall.

Air drying dramatically decreased copper runoff levels across both species and treatment types (Table 2). The initial 15 minutes of rainfall produced runoff with average copper concentrations ranging from 3.14-4.96 µg/mL, far lower than the 7.08-153.83 µg/mL range seen in wood with no BMP. Average copper concentrations steadily declined across both species and treatments with steady rainfall exposure, ending in the range of 0.99-3.19 µg/mL after 120 minutes of rainfall (Figure 2-5).

Steaming for 1,3, or 6 hours also decreased average copper concentrations in runoff from both species and treatment types relative to no BMP with the initial runoff concentrations ranging from 2.3-12.73 µg/mL (Table 2). Longer steaming times did not impart any obvious additional benefits above a one hour steam. In fact, the 6-hour steam appeared to slightly increase copper discharge from MCA-treated SYP relative to the 1 hour steam, but this difference was not statistically significant. The same downward trend in copper concentrations was observed over time in all cases and they reached a range of 1.03-3.85 µg/mL.

Soaking in a hot water bath for 1 hour was effective in reducing average copper concentrations in runoff from both species and treatment types relative to no BMP (Table 2). However, a longer 3-hour soak in a hot water bath led to much higher runoff copper concentrations than the 1-hour soak in some cases, ranging from 2.58-42.47 µg/mL. In one case, Wolman-Hem-Fir, the 3-hour soak actually led to higher copper concentrations in the first 30 minutes of rainfall than equivalent treatments with no BMP. Based on observations in this experiment, soaking in hot water for over 1 hour does not appear to be as effective in reducing copper runoff for MCA-treated wood as a shorter soak. Copper concentrations gradually decreased over time and after 120 minutes of rainfall ended between 0.70 and 1.95 µg/mL for the 1 hour soak and between 0.6 and 8.21 µg/mL for the 3 hour soak (Figure 2-5). A room temperature water bath was also tested as a BMP for MP200-Hem-Fir, Wolman-SYP, and Wolman-Hem-Fir. The treatment appeared to be successful in reducing runoff copper concentrations in all treatments tested. Reductions were less than those seen for the hot water bath for MP200-Hem-Fir and Wolman-Hem-Fir, despite the latter being undertreated relative to the wood used for no BMP (Table 1). Room temperature water soak was the most effective in reducing copper runoff from Wolman-SYP which had average runoff copper concentrations at 1.85 µg/mL after 15 minutes and decreasing to 0.51 µg/mL after 120 minutes. We did not test this method on MP200-SYP because we did not have enough material leftover from the treatment to test it.

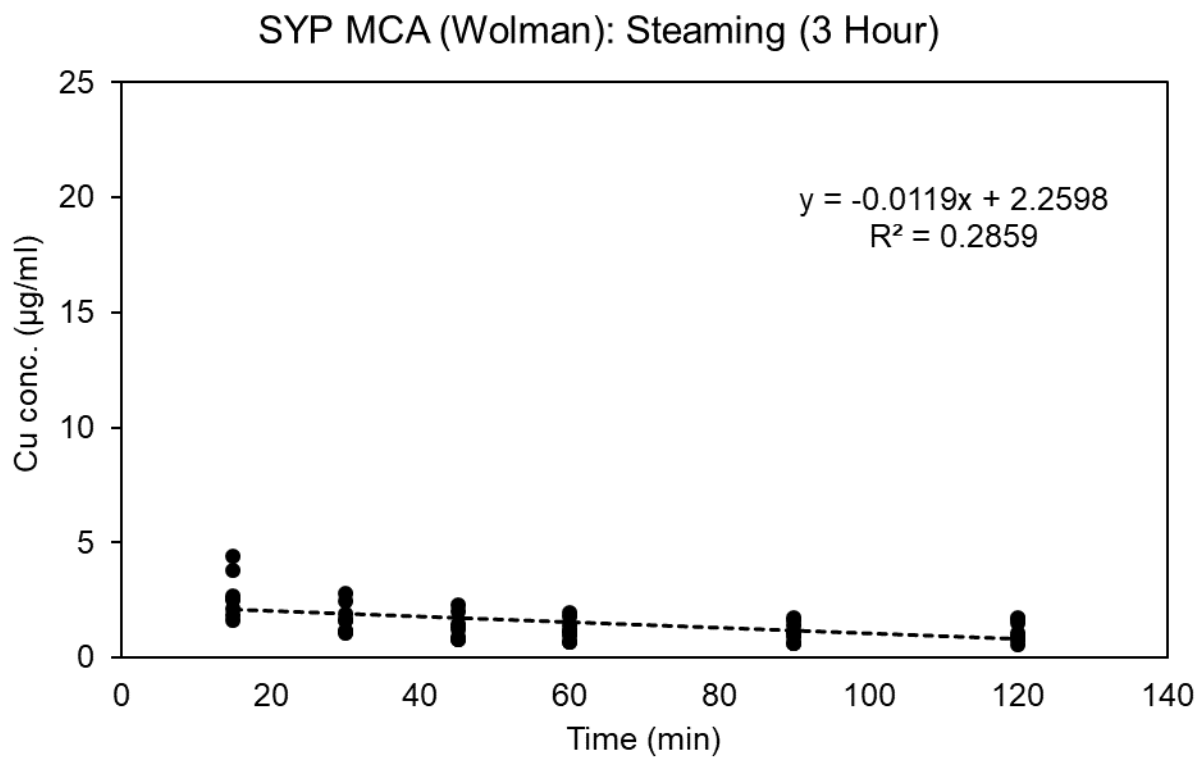
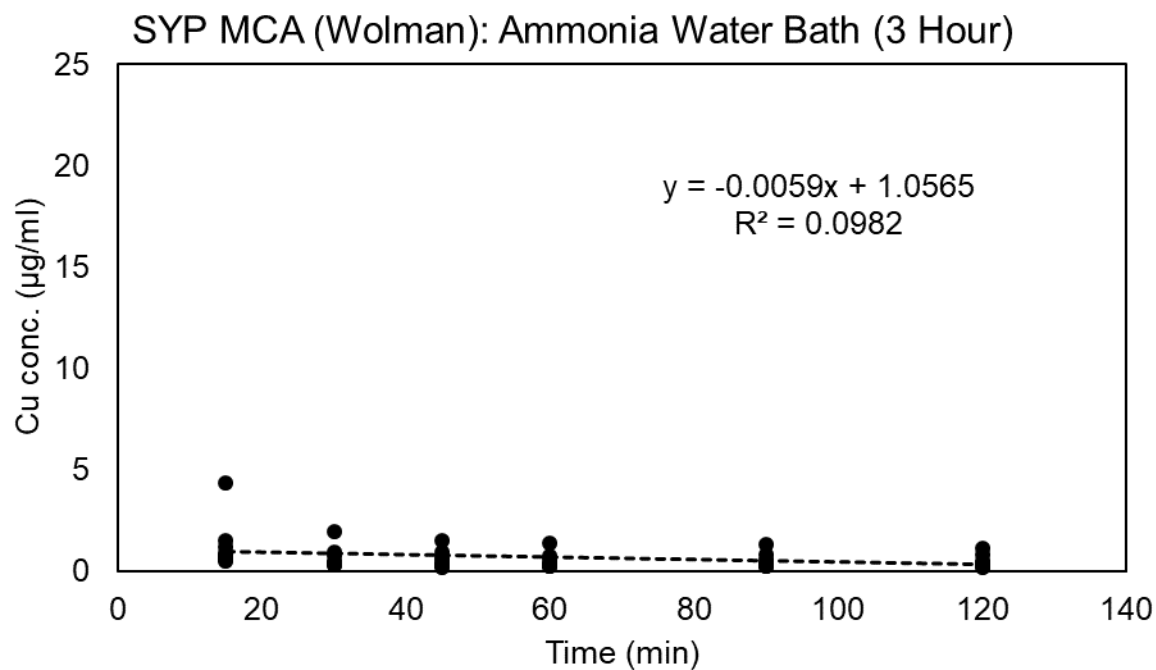
Figure 3. Effect of various BMP processes on copper losses from Wolman MCA-treated SYP lumber exposed to simulated rainfall.

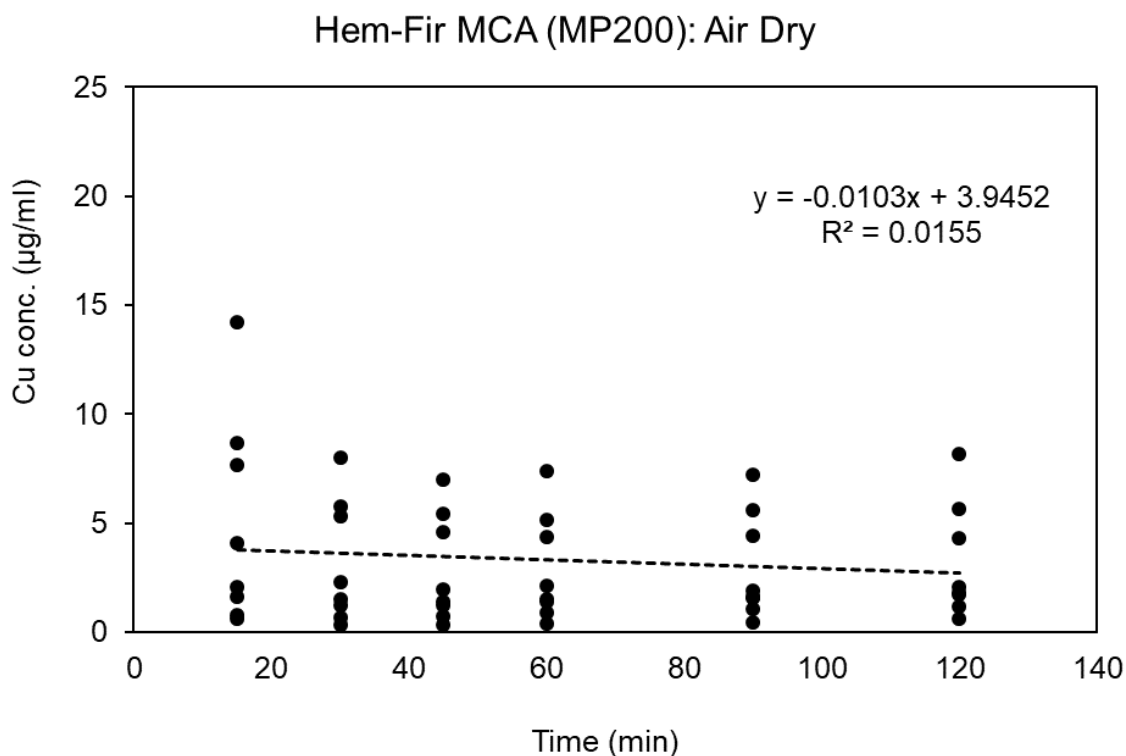
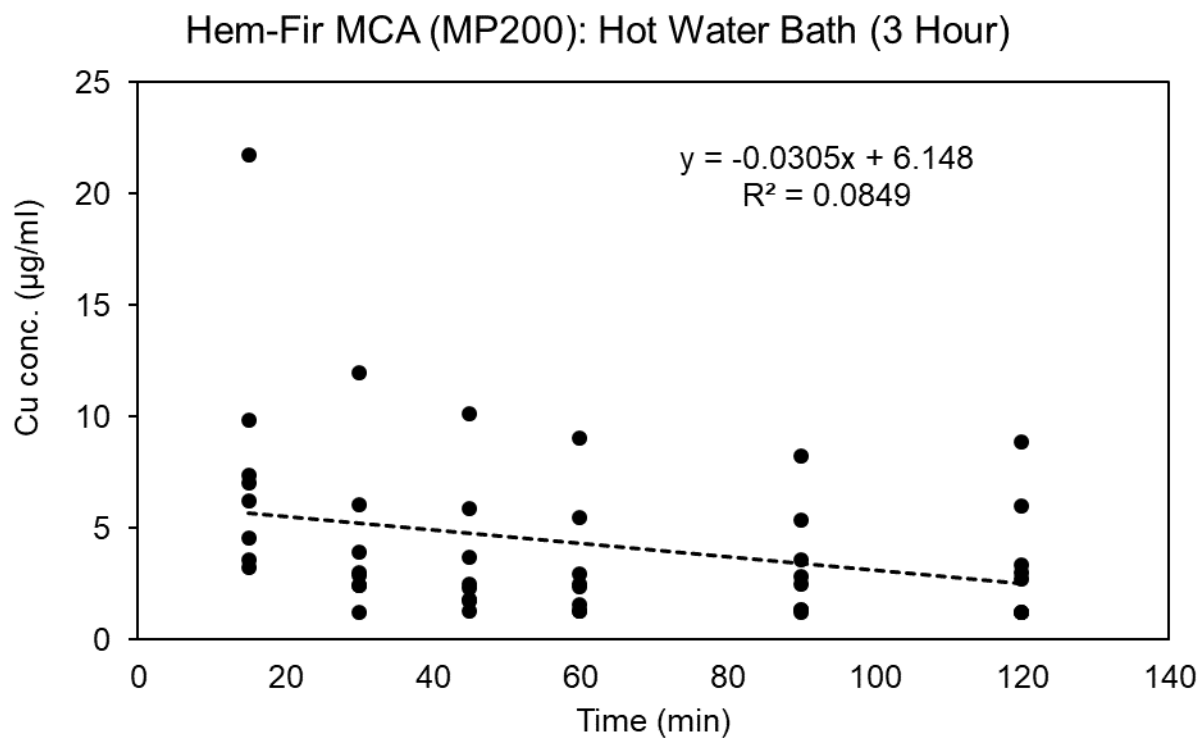
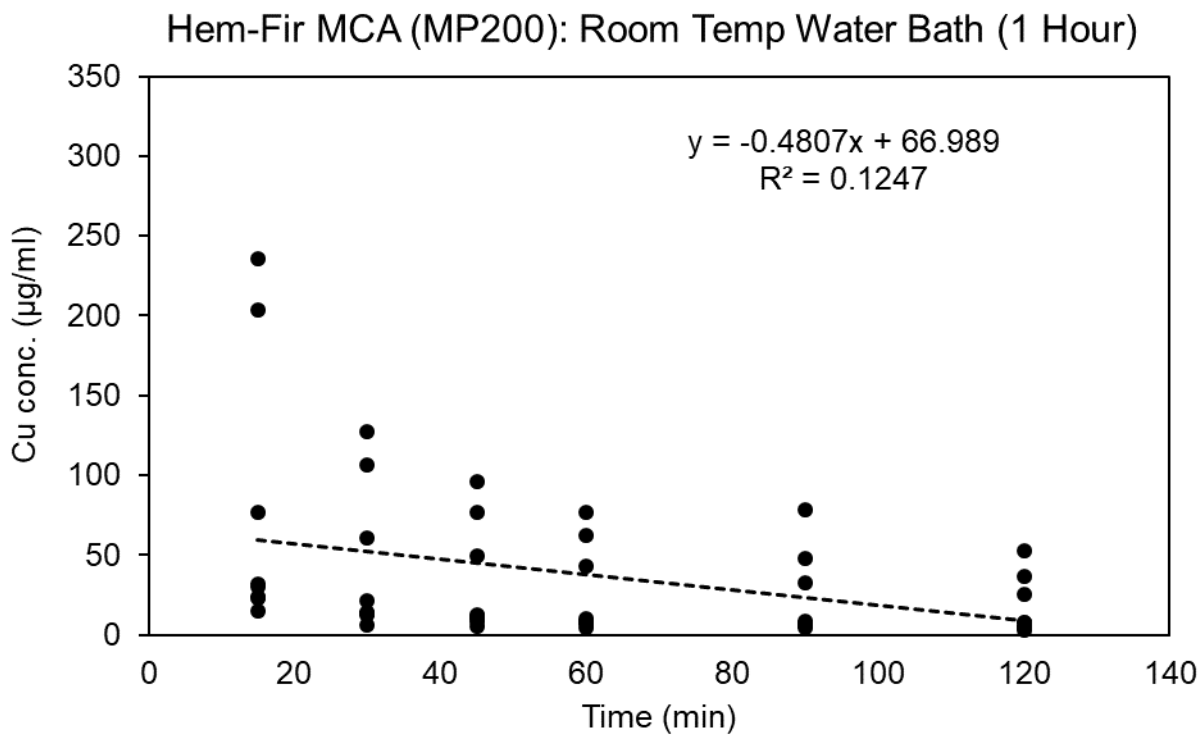
Figure 4. Effect of various BMP processes on copper losses from MP200 MCA-treated Hem-Fir lumber exposed to simulated rainfall. Note the difference in y-axis scale for no BMP treatment and room temp water bath as compared to all other BMP treatments.

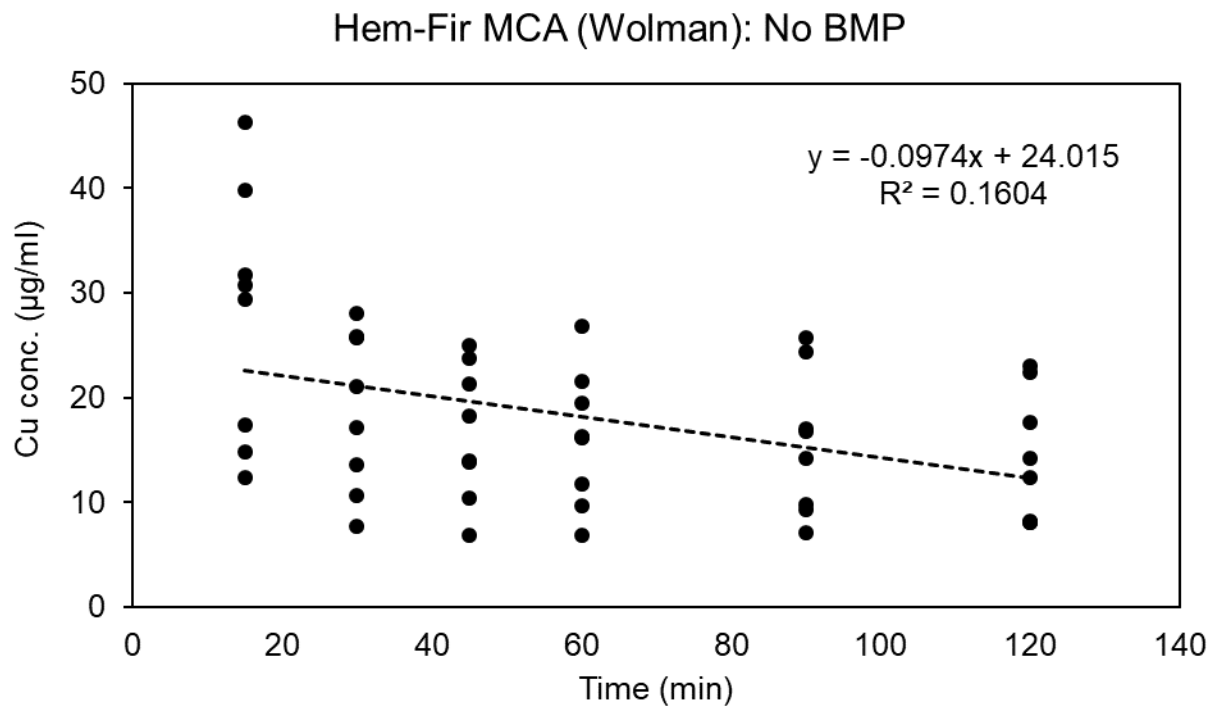
Figure 5. Effect of various BMP processes on copper losses from Wolman MCA-treated Hem-Fir lumber exposed to simulated rainfall. Note the difference in y-axis scale between 3 hour hot water bath BMP and all other treatments.

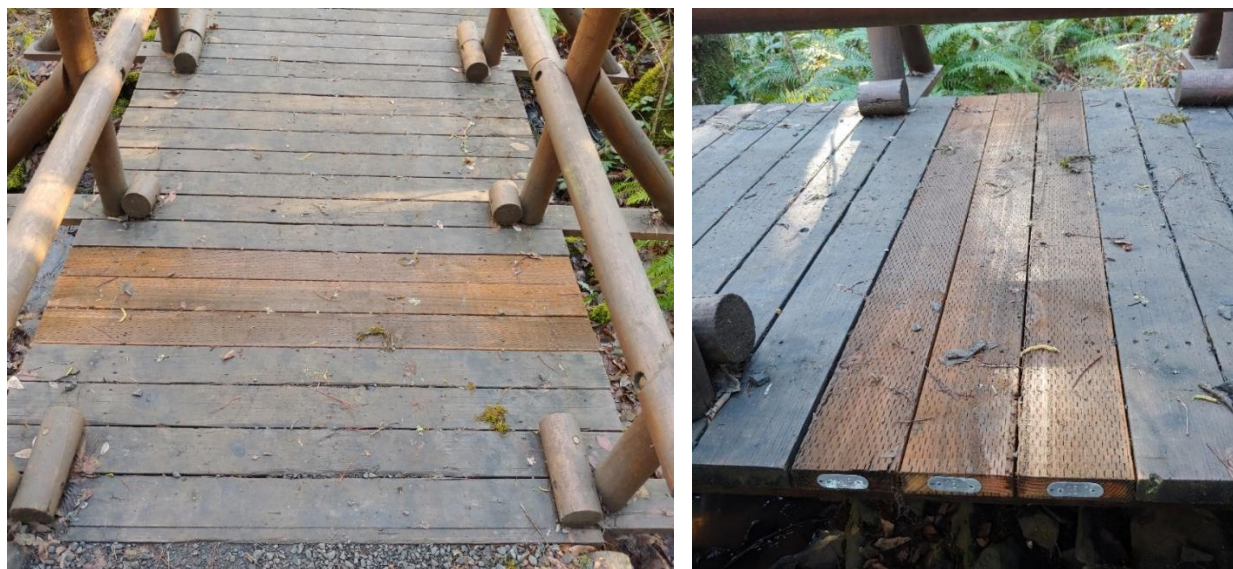
Figure 7. Deck boards used to assess abrasion rates in the bridge at Peavy Arboretum.

Copper azole treated DF lumber was purchased locally and cut to length. Samples were retained for later analysis, if needed. The lumber was conditioned to constant weight at 23 °C and 65% relative humidity before being weighed. The samples were then installed as replacement boards on the bridge (Figure 7). We expect that this project will take an extended period to show any measureable results, particularly because the boards must be weighed on a scale large enough to handle their size, which necessitates a loss in sensitivity. Because of this, the first sampling of this project will occur after a four-year period and weighed at four-year intervals after that. Boards will be reconditioned prior to weighing to determine mass loss. One other aspect of this project will be a need to determine the number of pedestrians crossing the structure. We intend to estimate potential foot traffic over this structure by acquiring estimates of the total number of visitors to the Peavy arboretum on an annual basis.
